Progress in Chamber Simulation Experiments At UCSD Laser Facility

Farrokh Najmabadi and Kevin Sequoia

HAPL Meeting

February 5-6, 2004

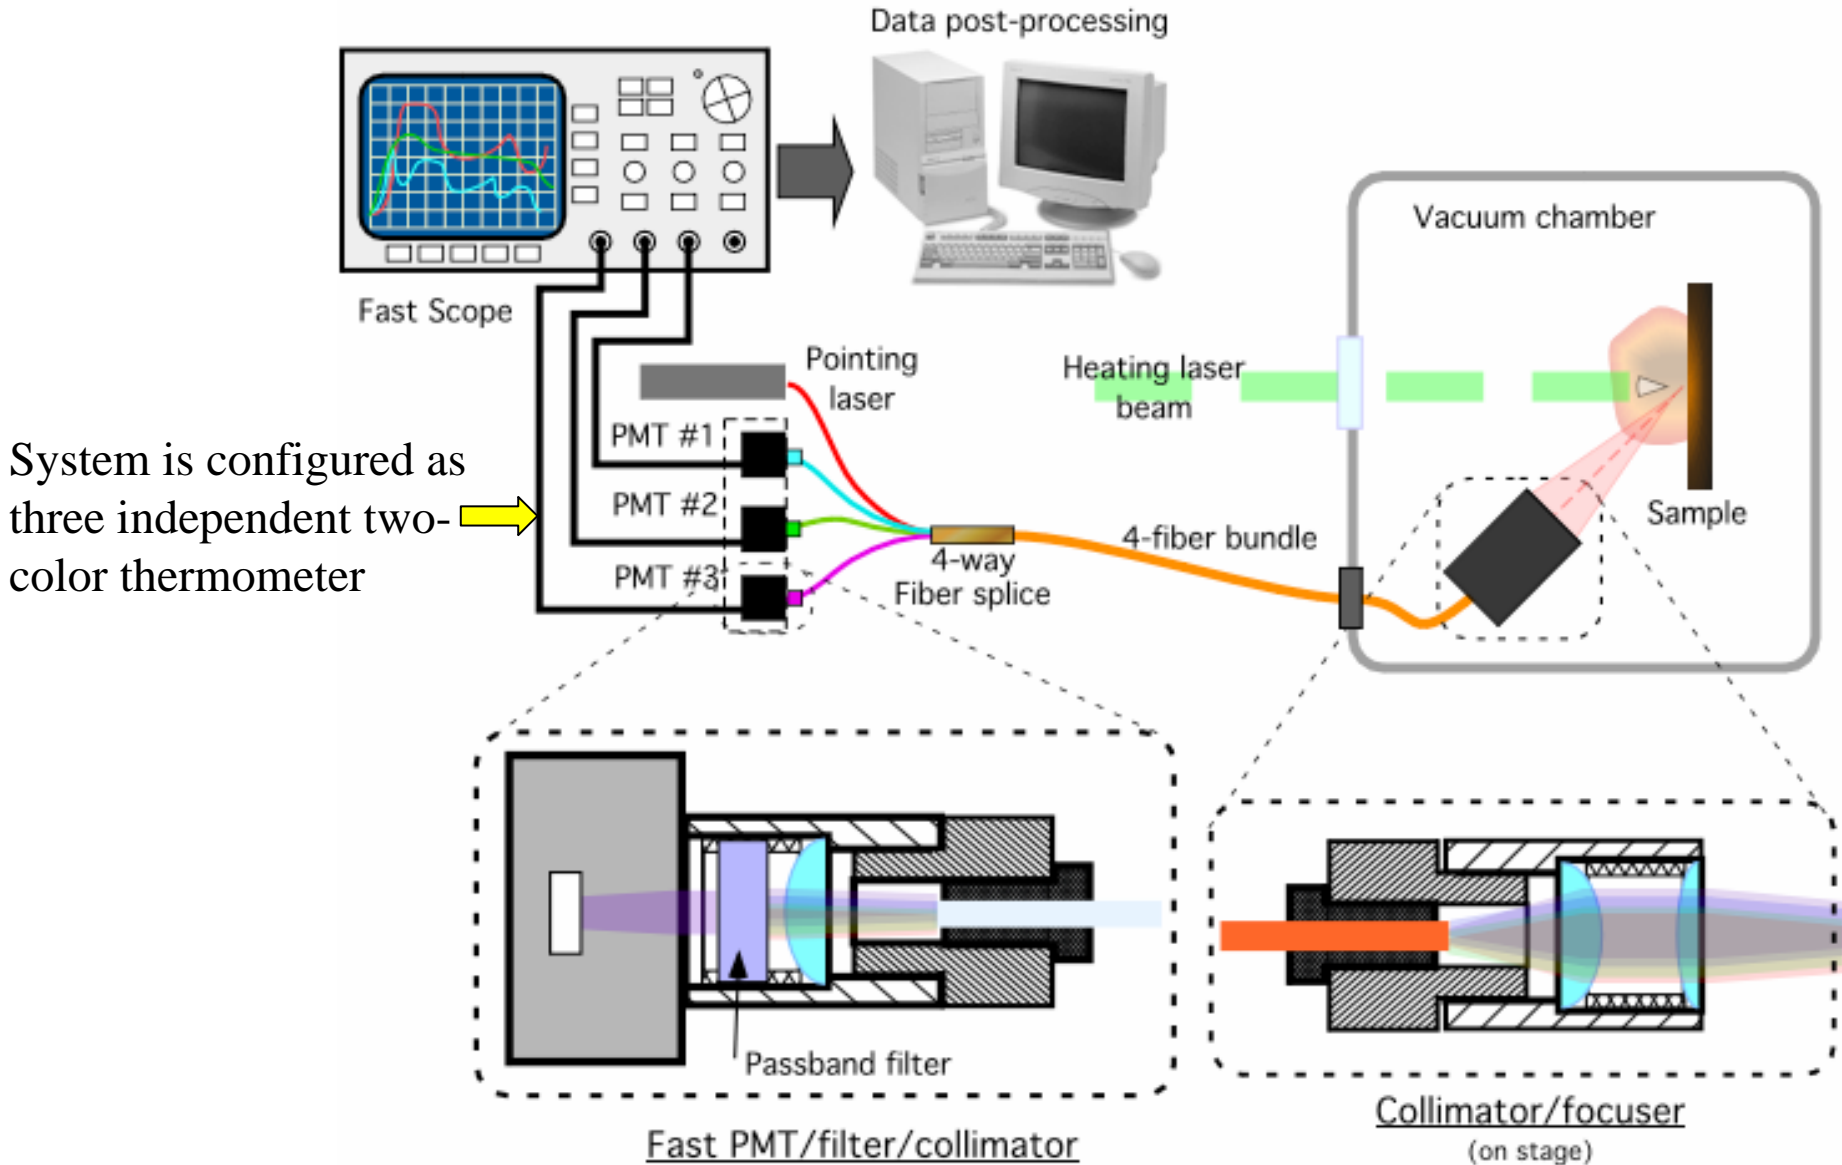
Schematic of Multi-Color Fiber Optical Thermometer

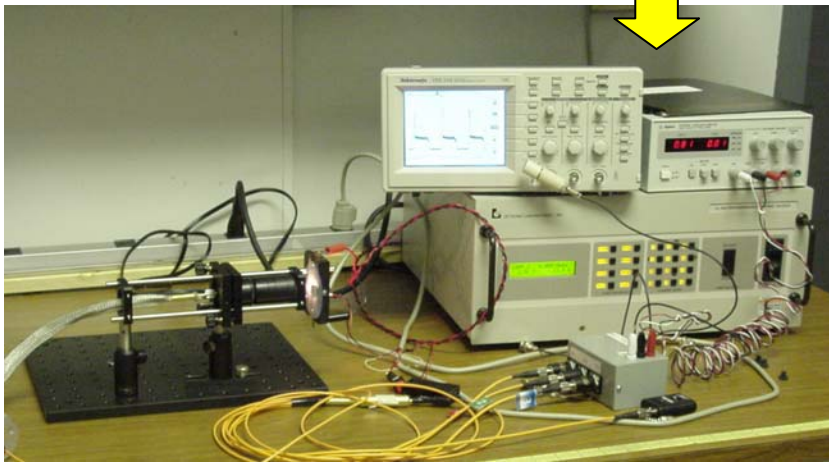
Calibration of Thermometer

- Temperature is calculated from measurement of radiated energy at two wavelengths:

$$T = \frac{\left[c_2 \left(\frac{1}{\lambda_1} - \frac{1}{\lambda_2} \right) \right]}{\left\{ \ln \left[\left(\frac{\lambda_2}{\lambda_1} \right)^5 \frac{L_{\lambda_2}}{L_{\lambda_1}} \right] \right\}} = \frac{\left[c_2 \left(\frac{1}{\lambda_1} - \frac{1}{\lambda_2} \right) \right]}{\left\{ \ln \left[\left(\frac{\lambda_2}{\lambda_1} \right)^5 \frac{C_2 V_2}{C_1 V_1} \right] \right\}}$$

Thermometer is calibrated with a tungsten lamp

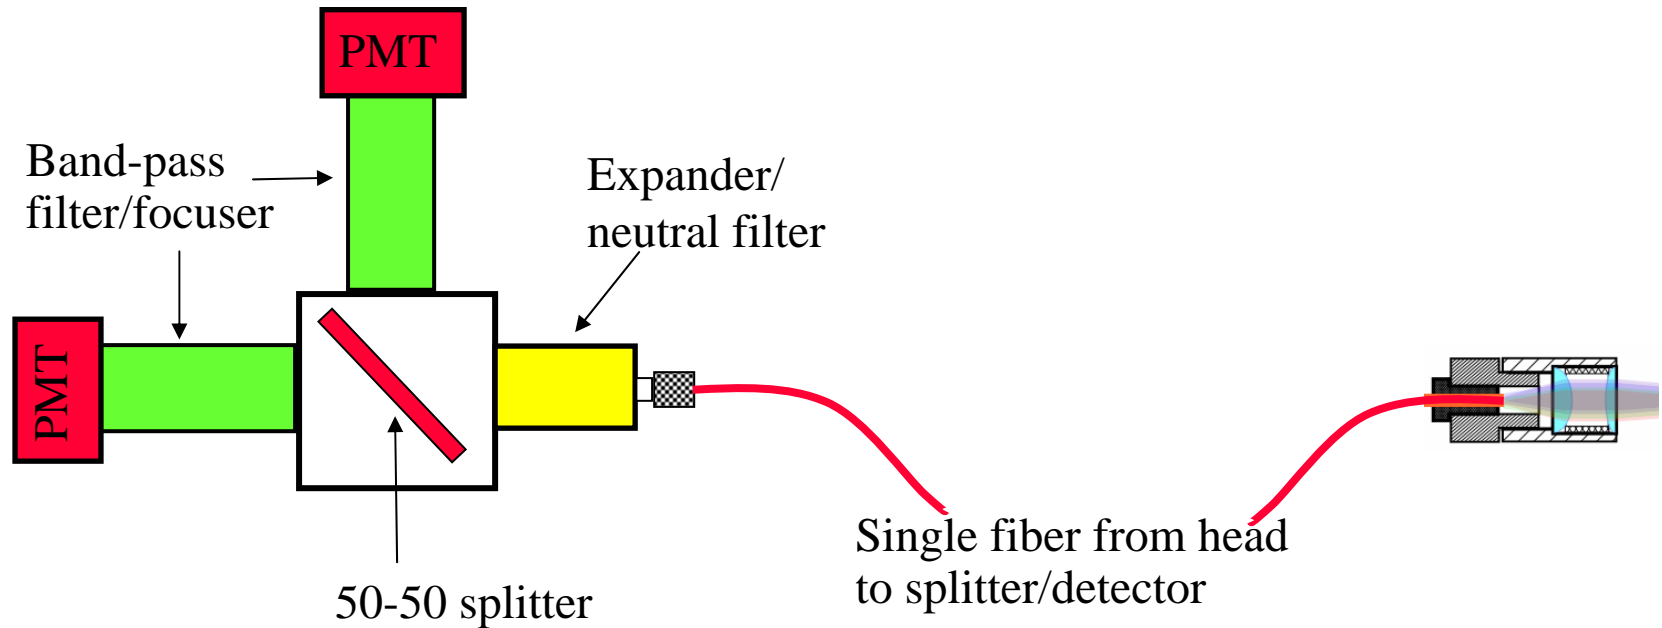
The New Design Uses a Single Fiber Coupler Between the Head and Splitter/Detector Assemblies

- The optical signal is split in the detector assemblies as opposed to the head.
- We have achieved excellent reliability!
- Bonus: A factor of 2-4 reduction in fiber insertion loss!

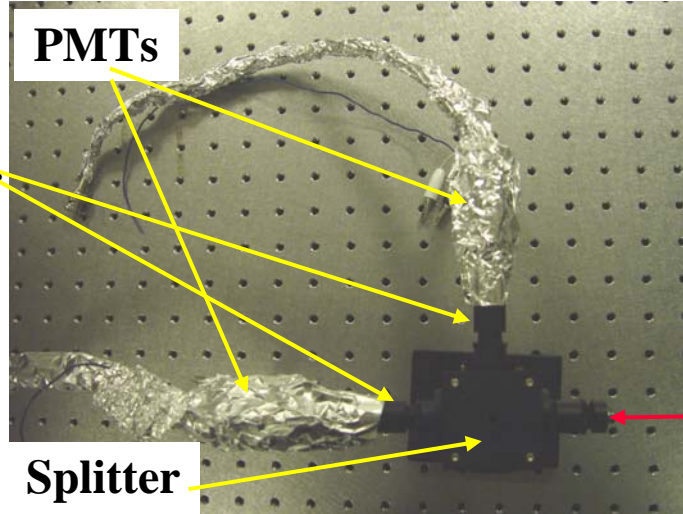
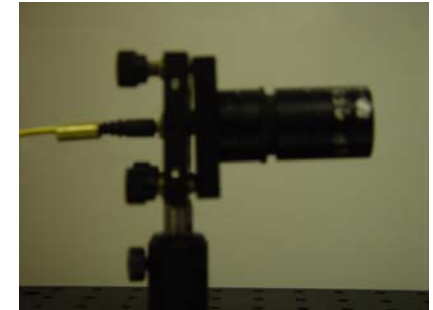
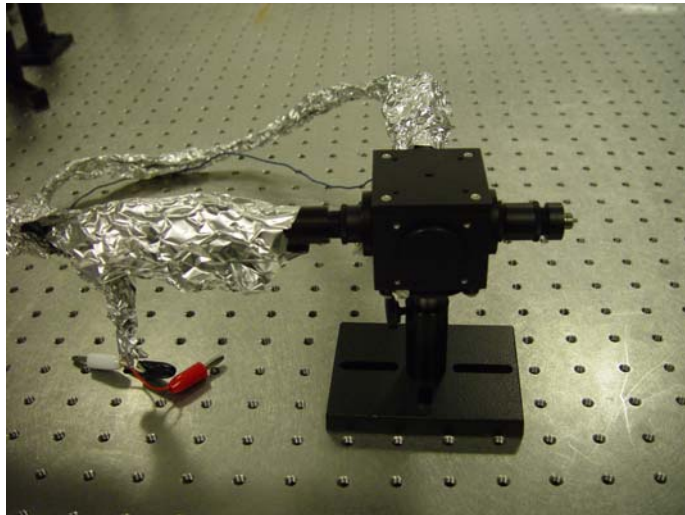
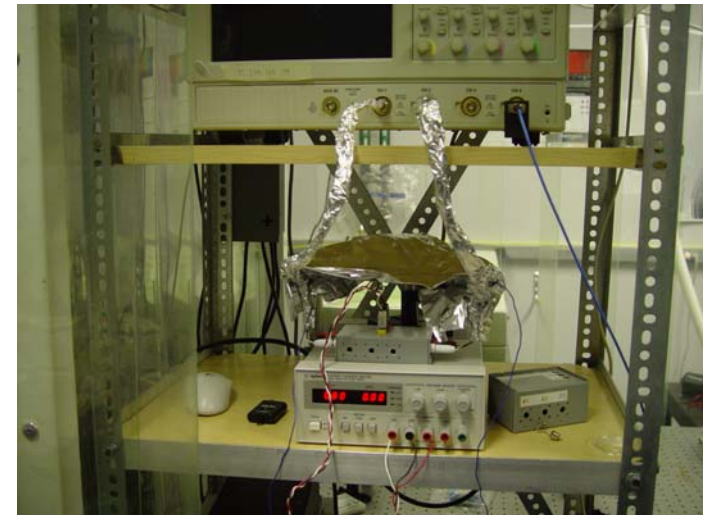
The Head and Splitter/Detector Assemblies Are Packaged in Robust, Low-Profile “Packages”

Band-pass filter/
Collimator/focuser
